Impact Area Groundwater Study Program

Final Central Impact Area Source Investigation Summary Report

Massachusetts Military Reservation Cape Cod, Massachusetts

July 2011

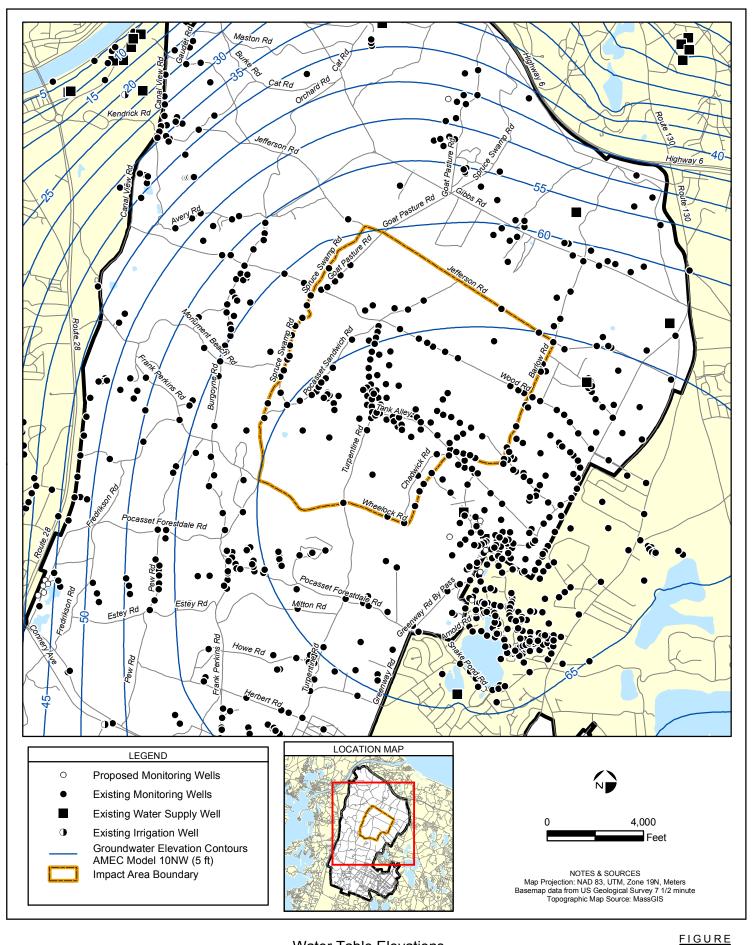
Water Table Elevations

The groundwater flow direction from the Central Impact Area is predominantly to the northwest (Figure 2-4) and the hydraulic gradient steepens with increasing distance from the top of the regional potentiometric groundwater mound. Within the Central Impact Area, groundwater elevations typically range between 65 and 70 feet National Geodetic Vertical Datum, and depth to groundwater ranges from approximately 100 to 140 feet below ground surface (bgs). Based on the observed response of the water table relative to recharge events, the hydraulic travel time through the vadose zone is expected to be three to six months. The thickness of the saturated zone varies between 180 and 280 feet.
